## WHITE WATER RESTORATION EFFORTS

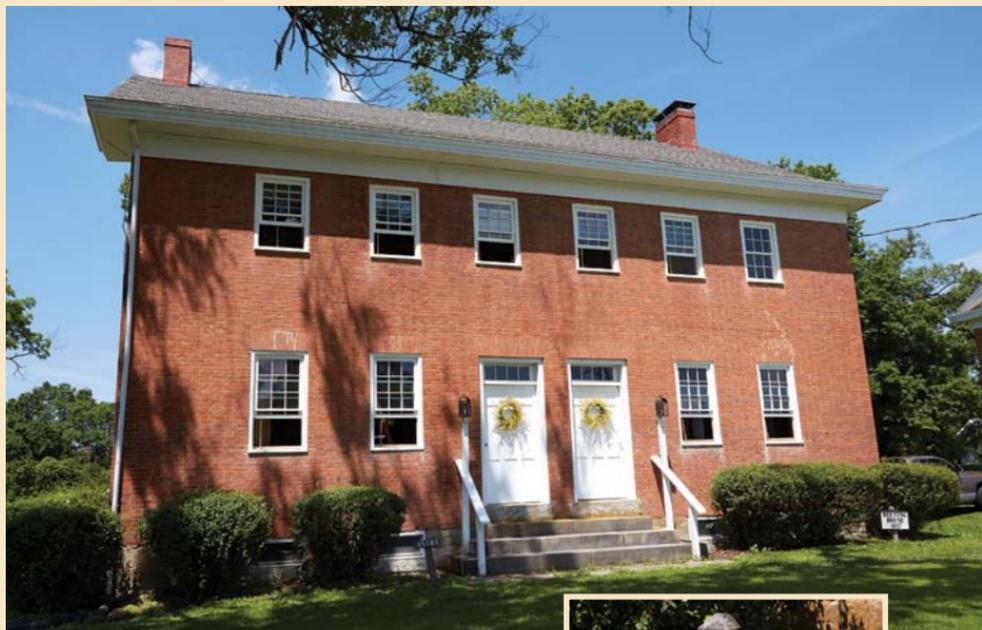
**Meeting house.** The 1827 brick meeting house – the only extant brick example in any Shaker community – has undergone significant structural work since our first visit in 2009. The trusses, joists and more were brought up to code so the building is safe for visitors, and the 1950s windows have all been replaced with period reproductions in walnut to match the originals, a job that cost \$36,000.

Now that significant structural work has been completed on the building to bring it up to modern code, and 30 replica windows with period glass as well as many feet

of missing wainscoting have been installed, volunteers Joe Grittani (vice president of the Friends) and Dave Coleman are hard at work replacing the poplar flooring that was torn out on the second floor. Next, they will reframe the missing second-floor walls in their original locations after which the rewiring can be completed, then plaster will be applied. They'll also rebuild the original staircase to the attic.

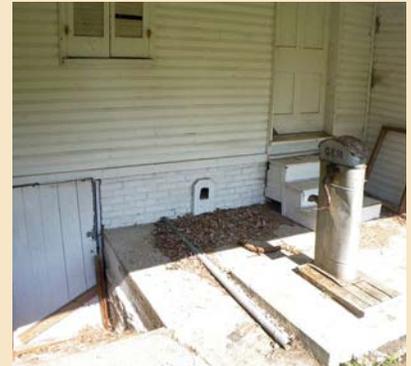
**No spring.** Unlike a spring house that would have water running through it, the Milk House at White Water has a pump outside that directed water through a pipe into troughs inside. Presumably, cool water was pumped into the structure by passers-by.

But the structure that Joe is most excited about working on is the Milk House – a curious gem unlike any other he's seen. The frame building atop a brick and stone foundation has no stream running through it as would a typical spring house, but there's a pump outside that directed water through a pipe into troughs

around three of the walls on the lower floor. "We think that when community members walked by, they pumped the pump a few times," he says. Overflow was directed through a pipe out the back, perhaps into a watering trough for livestock in the field behind. "The Milk House is going to require a ground-up rebuild, but I want to make sure that one is saved," Joe says.

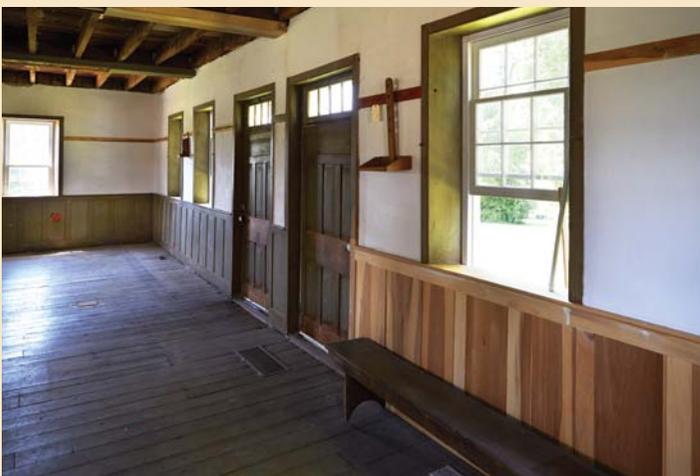
**Wainscoting.** Volunteers Joe Grittani and Dave Coleman made and installed replication poplar wainscoting to replace the many missing sections on the first floor of the meeting house. At the back of the picture, you can see original panels; the unpainted sections are new. Notice, too, the open ceiling; all the plaster had to come down to rip out old wiring and to install joist hangers that support 100 pounds per square foot.

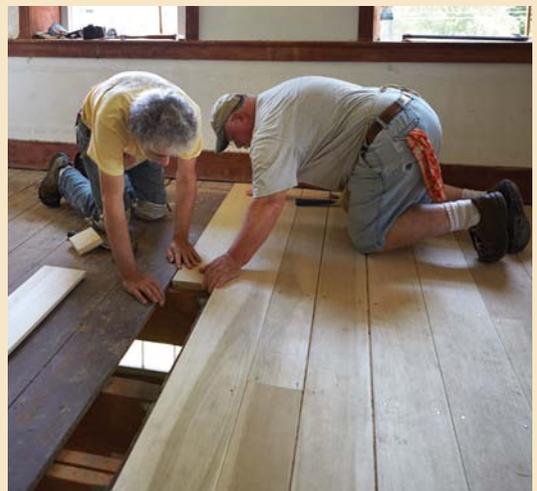
**Flooring.** By the time this is printed, Joe and Dave will be finished installing custom-milled poplar planks that match the original flooring. The plan is to wash the old floor then use the dirty water to "stain" the new floor so that they more closely match.
